SOIL EVALUATION SERVICES INC.

Re: Soil borings in and around existing church.

Site and Soil Evaluation Report

Title	Soil Boring Locations		
Reference Subtitle	Historic Christ Church, Lancaster Co., VA Specific Site Layout		
Drawn By	DRM	Approved By	DRM
Date	10/6/2017	Scale	1" = 50'
Revision	0	Drawing No.

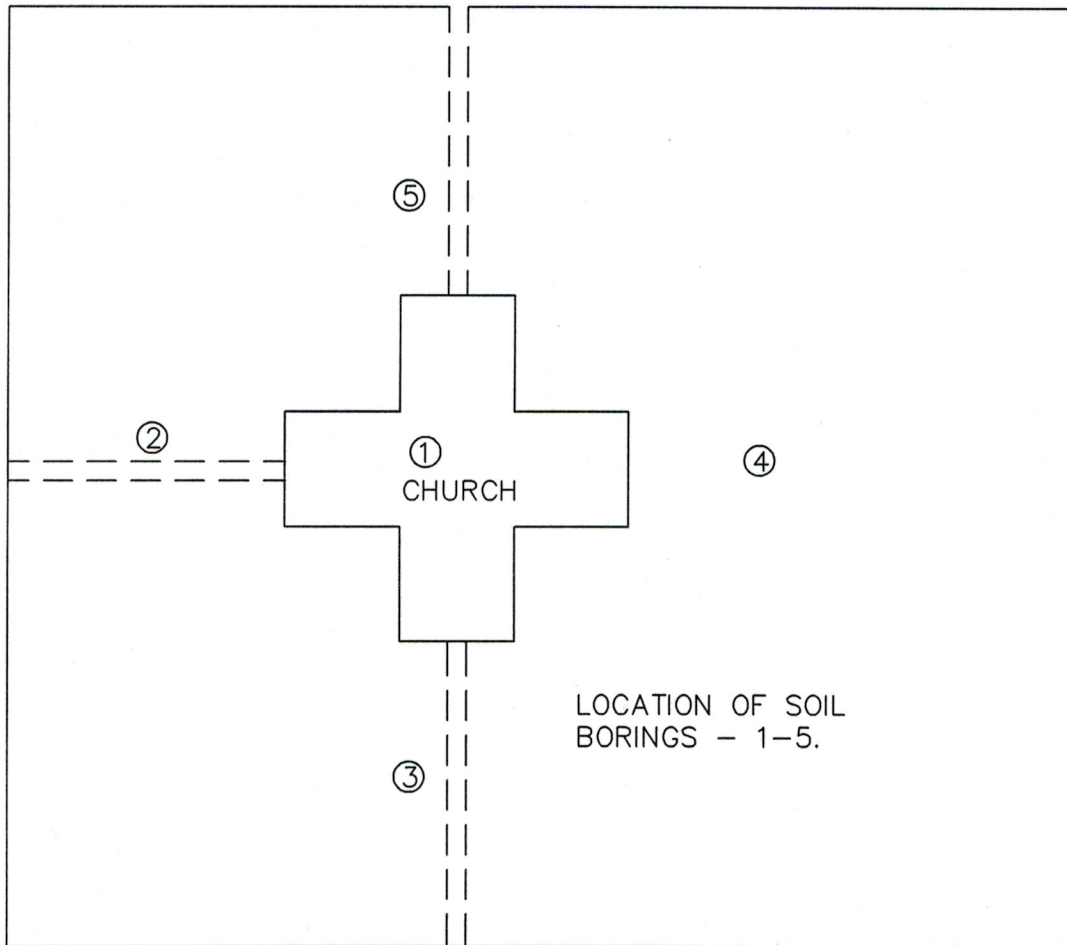
BORINGS 2-4 PLACED 30' OFF OF BUILDING. BORING #5 PLACED 22' OFF BUILDING DUE TO HITTING BRICK, OTHER DEBRIS, ETC. AT 30' OFF BUILDING.
